AERIAL PHOTOGRAPHIC ANALYSIS OF THE LARSON AFB STUDY AREA Moses Lake, Washington

EPA Region 10

TS-PIC-89818/90818-1
November 1989

M. A. Finkbeiner
Environmental Programs
Lockheed Engineering and Sciences Company
Las Vegas, Nevada 89193-3478

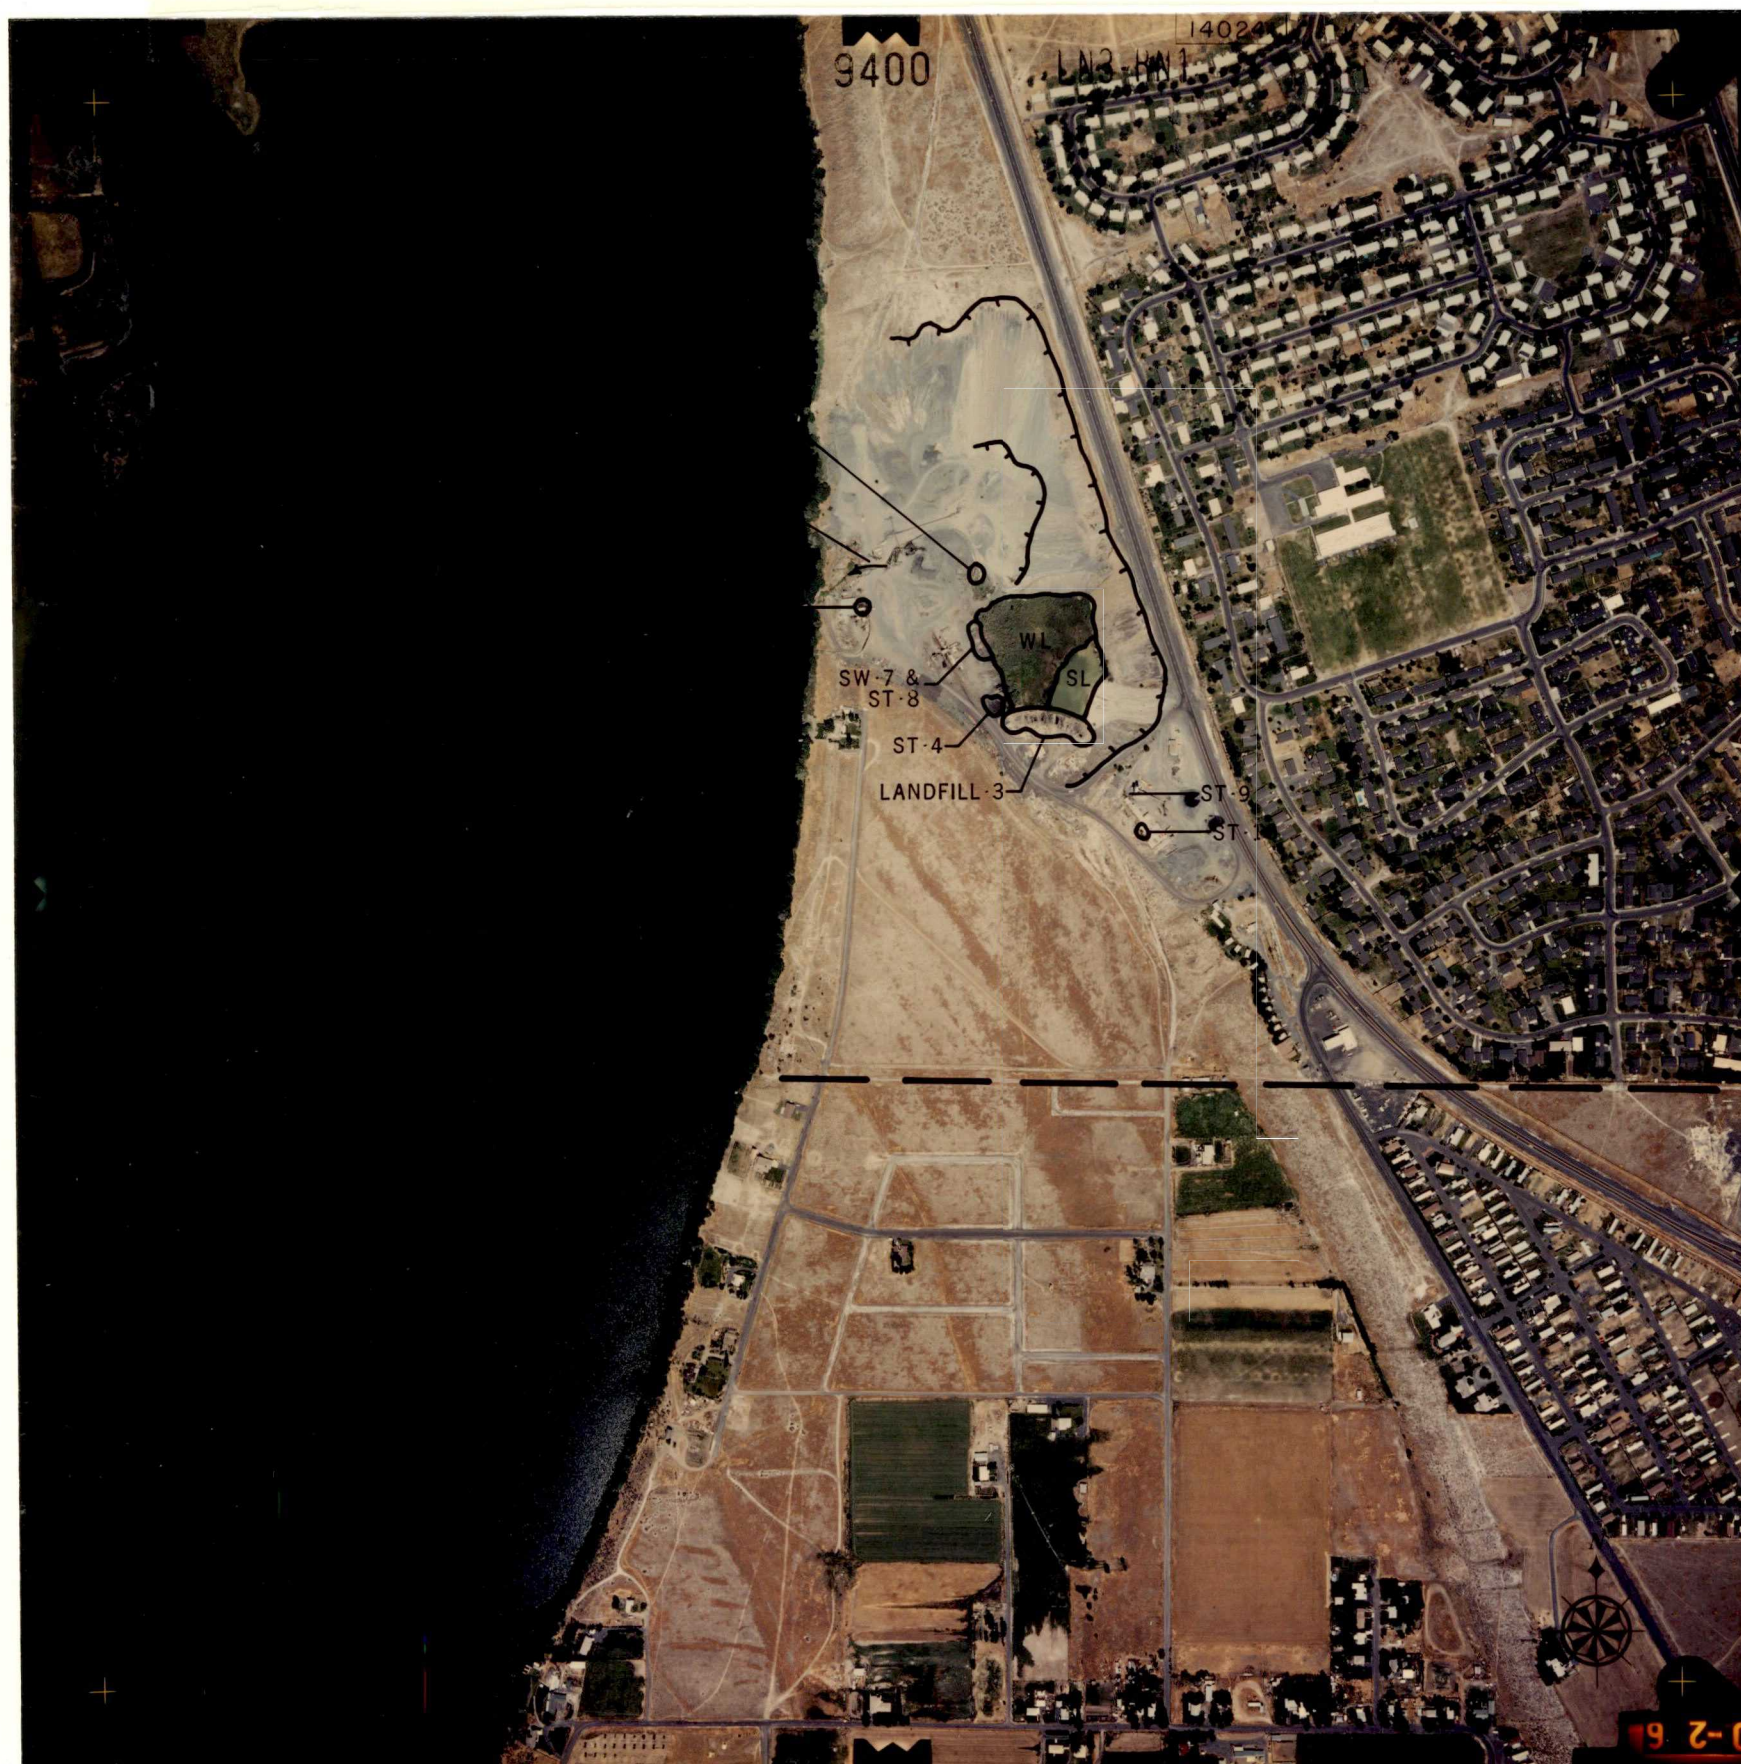
Figure 20 shows a major gravel extraction pit and waste disposal area where staining and solid waste were noted in 1973. This area has been expanded since that time. Potential environmental hazards are:

- Landfill-3: A mix of various solid and liquid wastes, as well as fill material or construction rubble have been dumped into the old gravel pit along this front. Numerous stains and metal objects are distinguishable.
- SW-7/ST-8: This area seems to be the scene of the same type of waste disposal as at landfill-3; however, no filling of the area is apparent.
- ST-4: This dark stain shows essentially the same appearance as in 1973.
- ST-7: An extensive stain is visible at this point. The source appears to be rinsing operations at the garage nearby.
- ST-9: This stain appears to be the result of an oily liquid spill or release from the adjacent maintenance building.
- ST-10: Staining at this point is probably from leakages from drums or other containers stored along the edge of the slope. None of the stains have reached the road to the southwest.

Additional features of interest are several abandoned and rusting tanks which have been dumped near the wetland. No leakage of contaminants can be identified at these tanks.

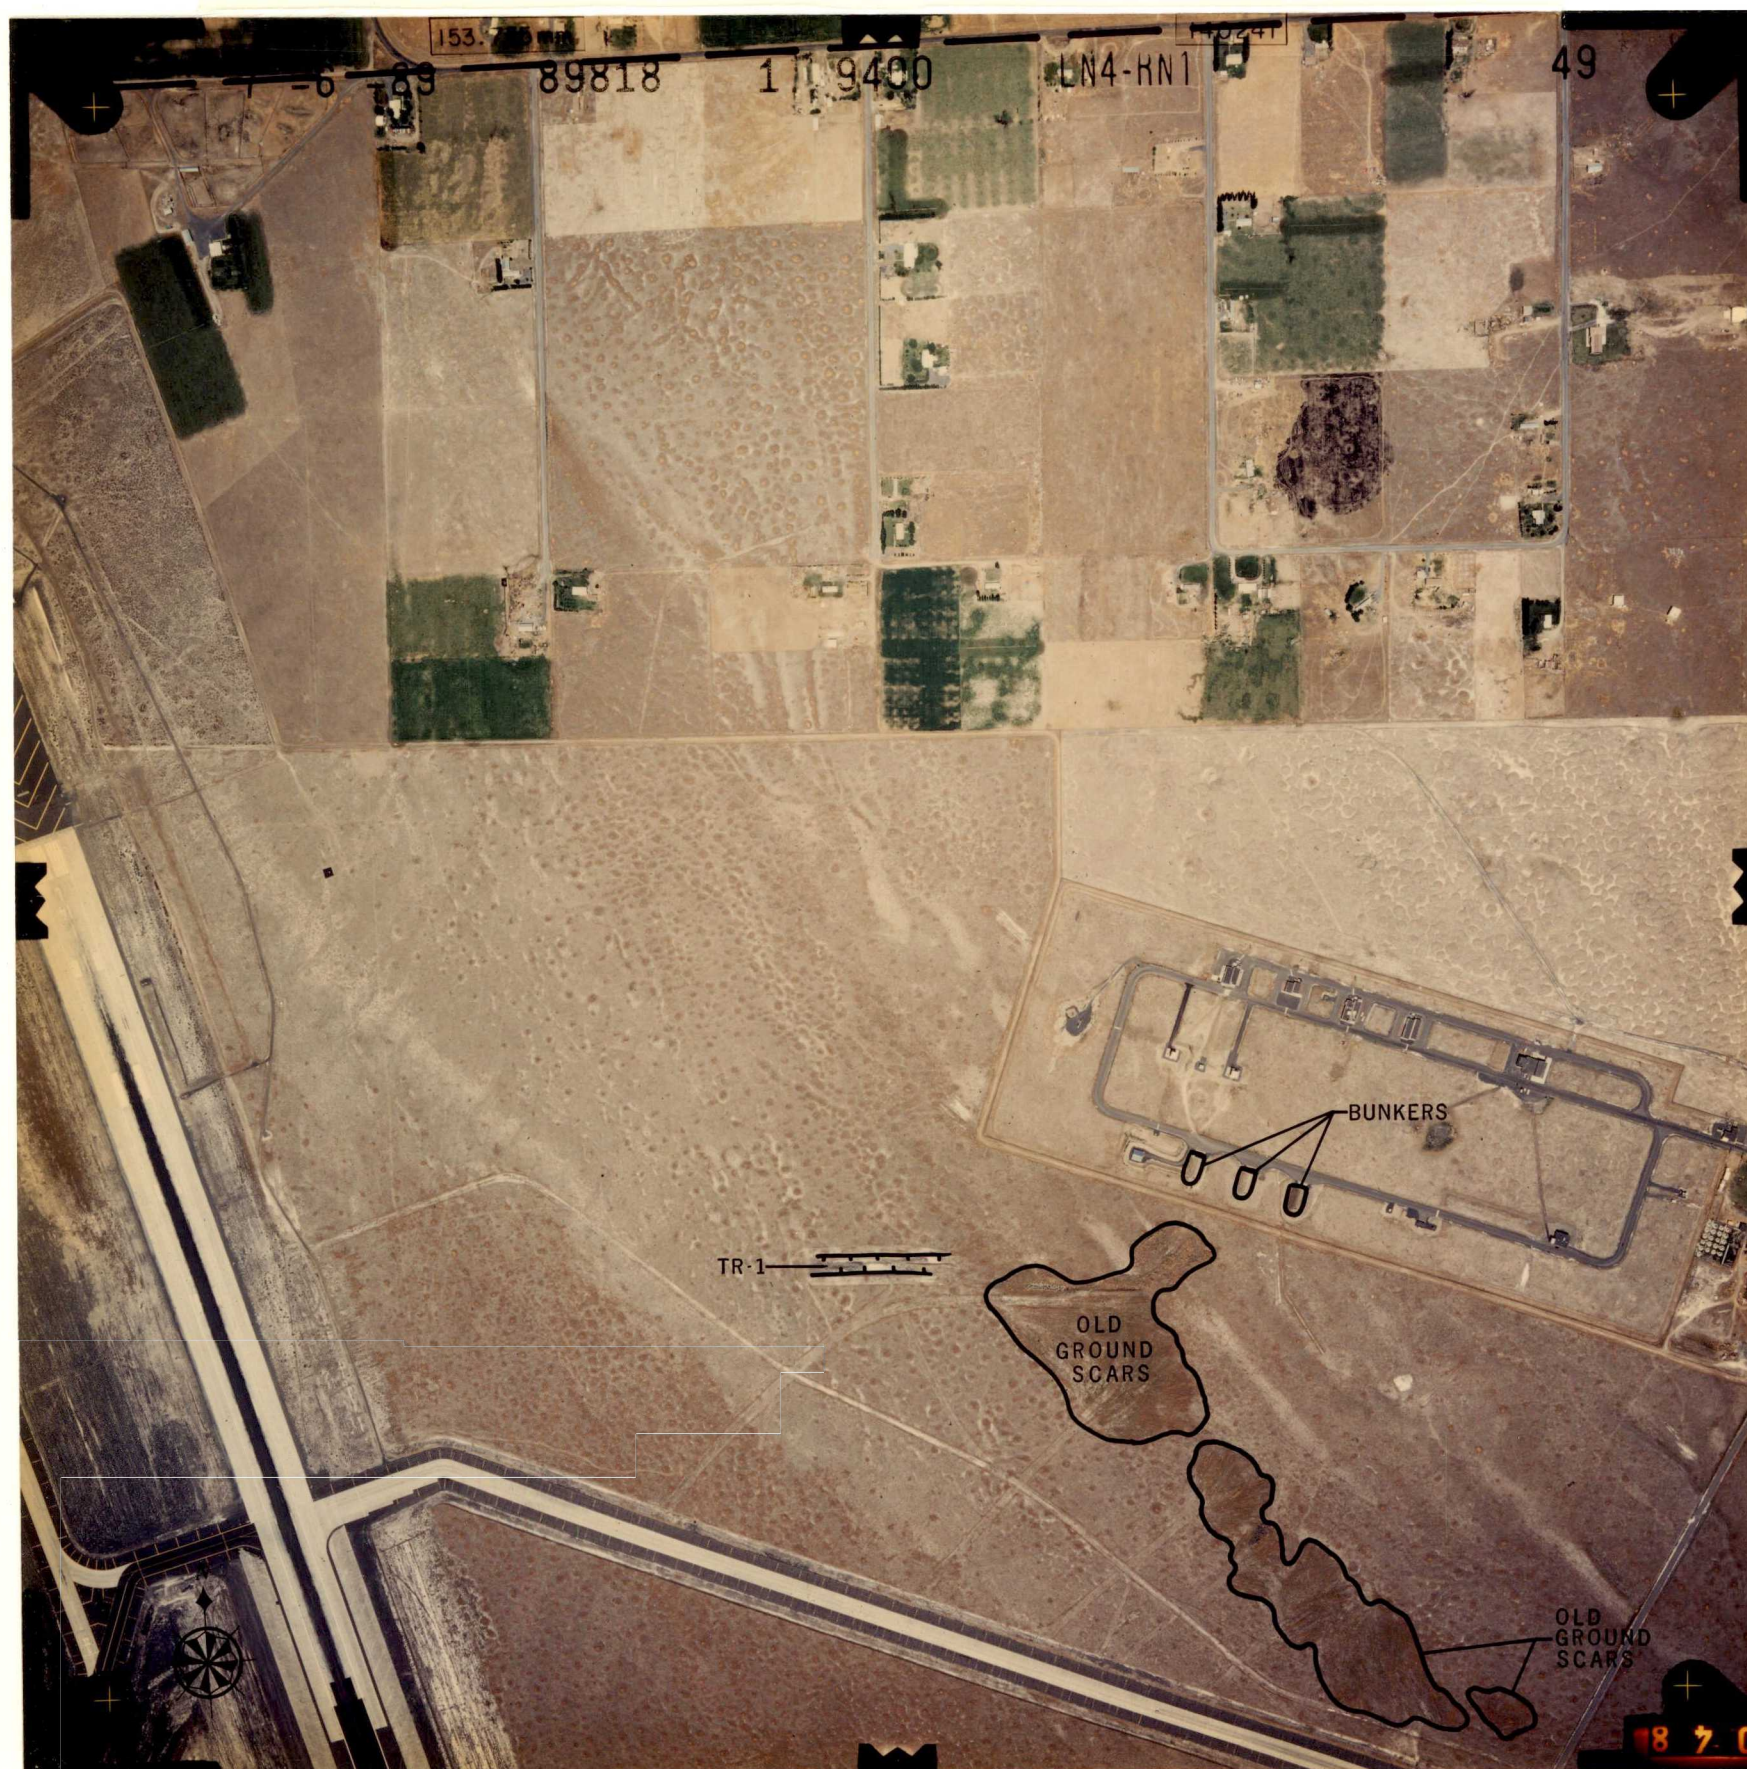
Figure 21 shows a relatively low level of activity in this part of the study area. Many features have the same appearance that they did in 1973. Potential environmental hazards are:

TR-1: No change or new waste disposal is evident.

The areas of ground scarring cover the same area as in 1973 and show signs of revegetation.

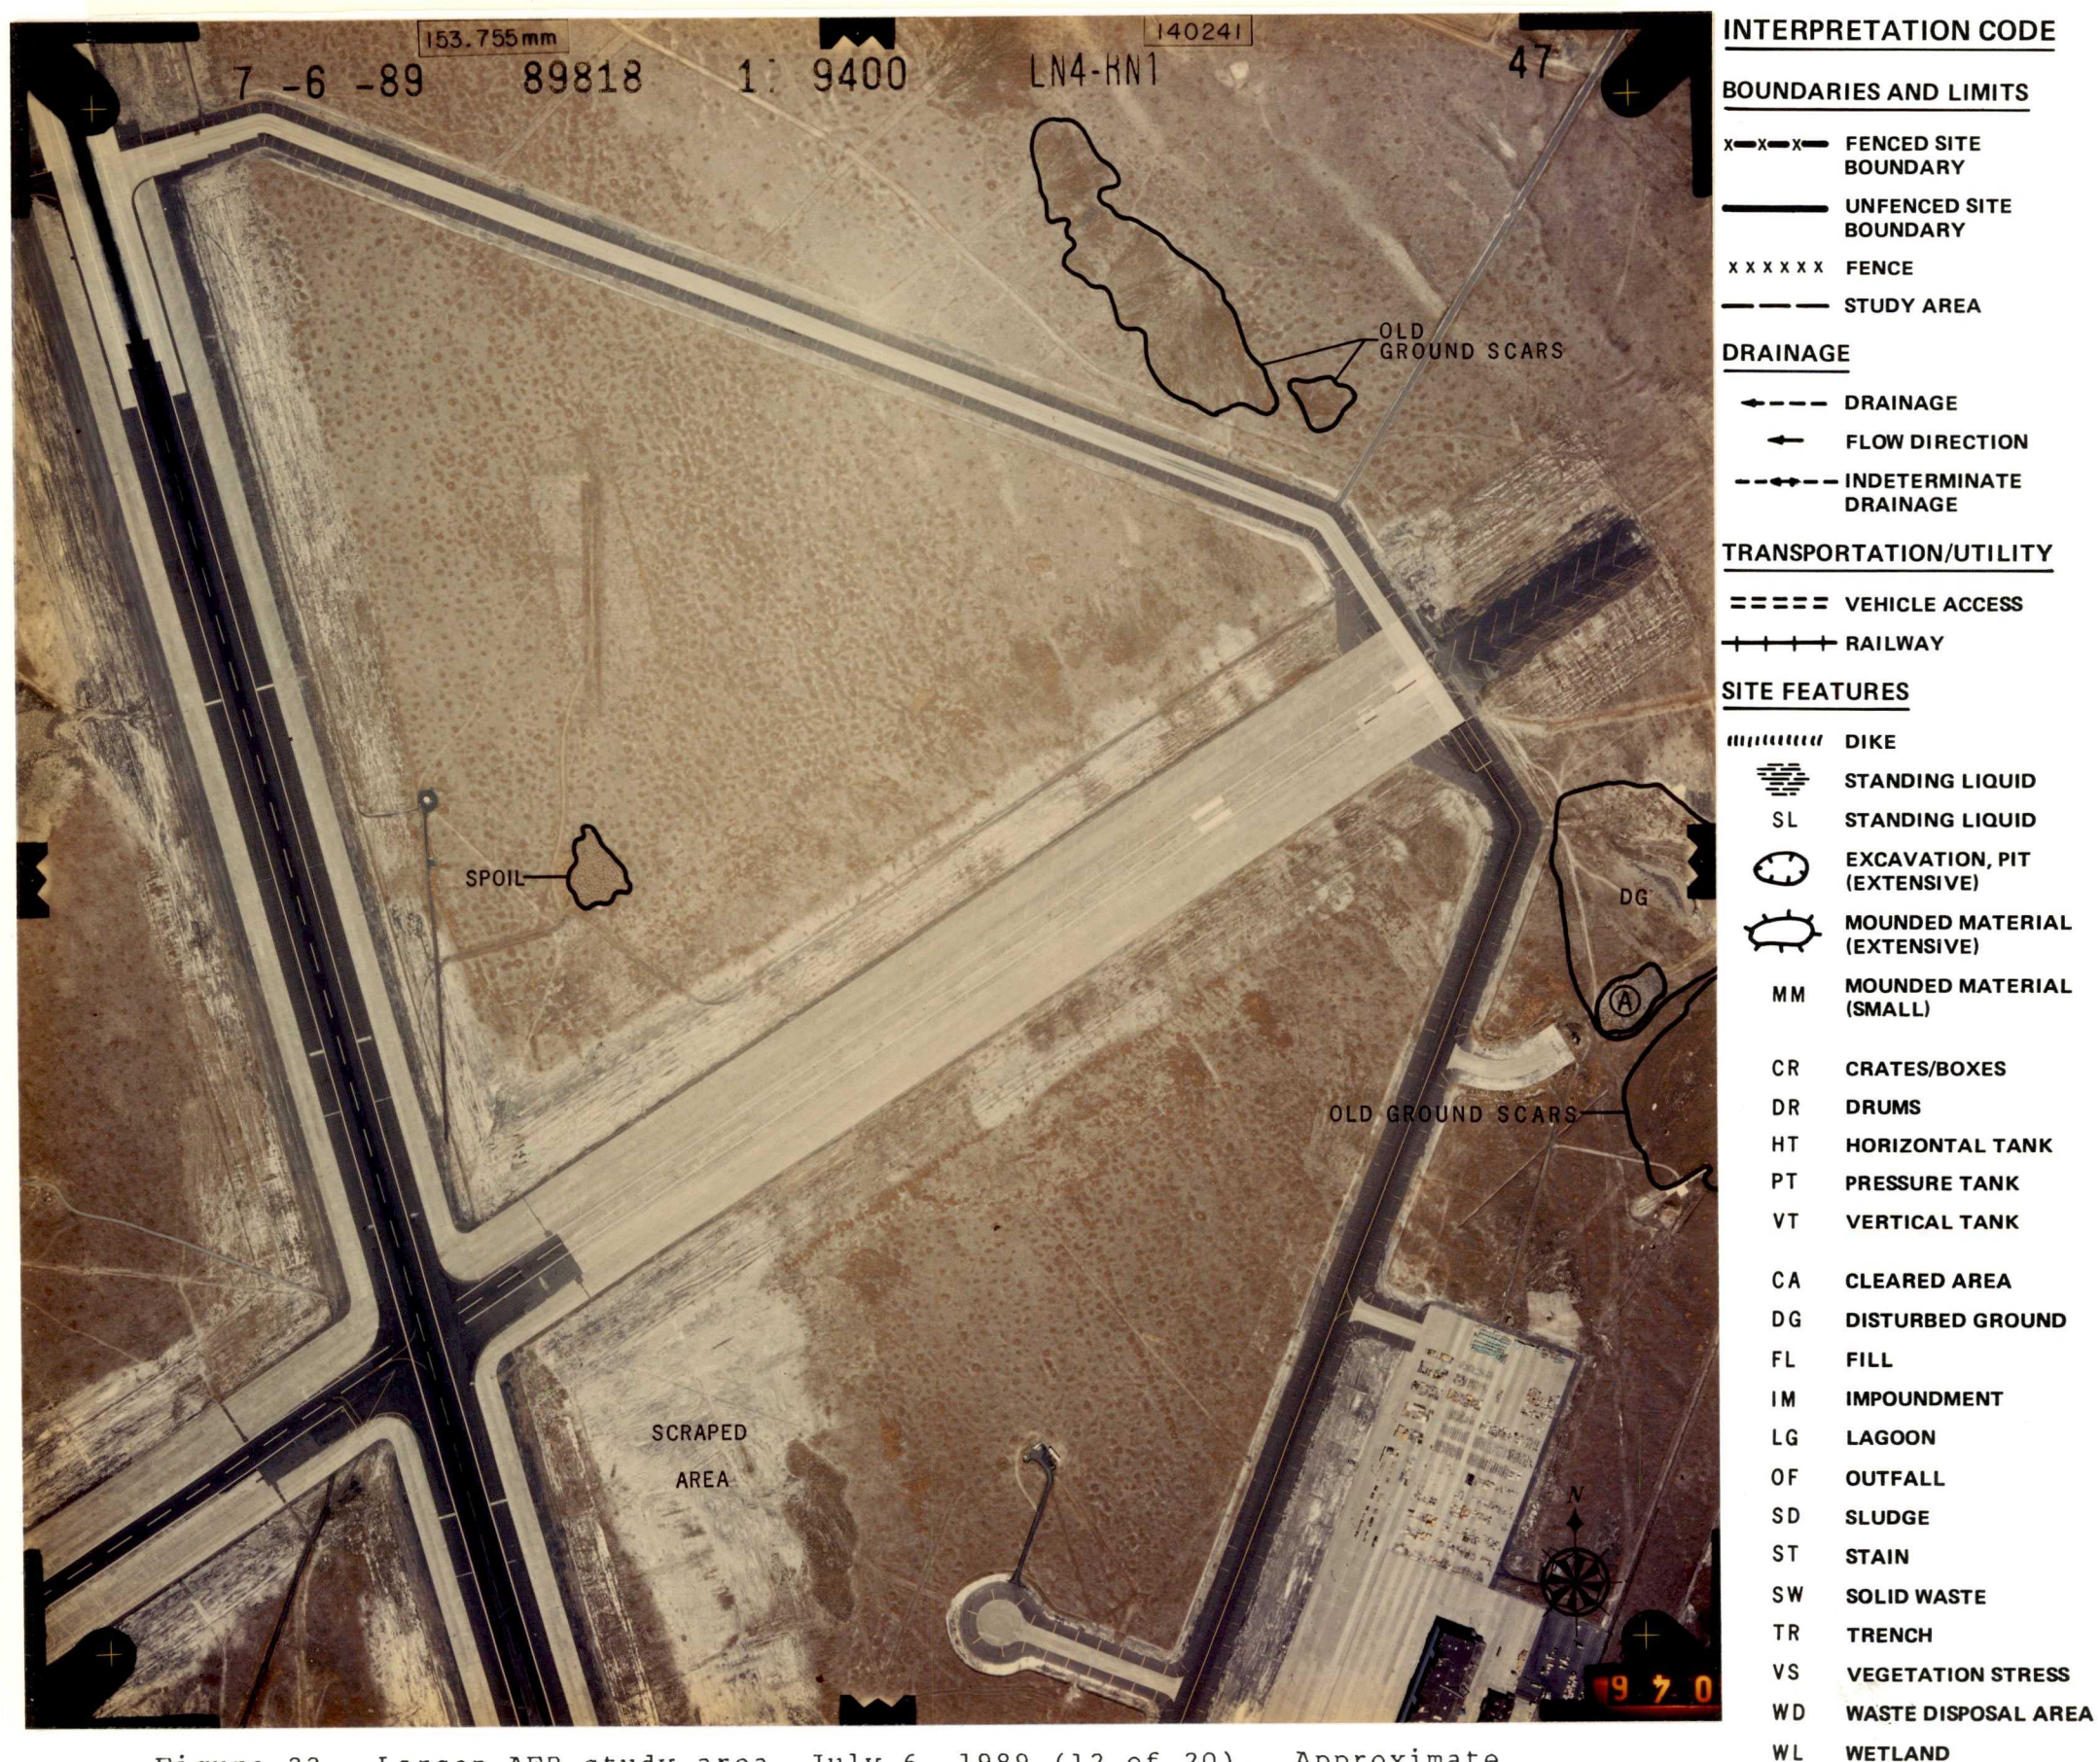
Figure 22. Larson AFB study area, July 6, 1989 (12 of 20). Approximate scale 1:9,400.

Figure 22 shows a similar lack of change at most of the study area. Potential environmental hazards are:

Annotation A: The appearance of this mounded solid material has not changed since 1973.

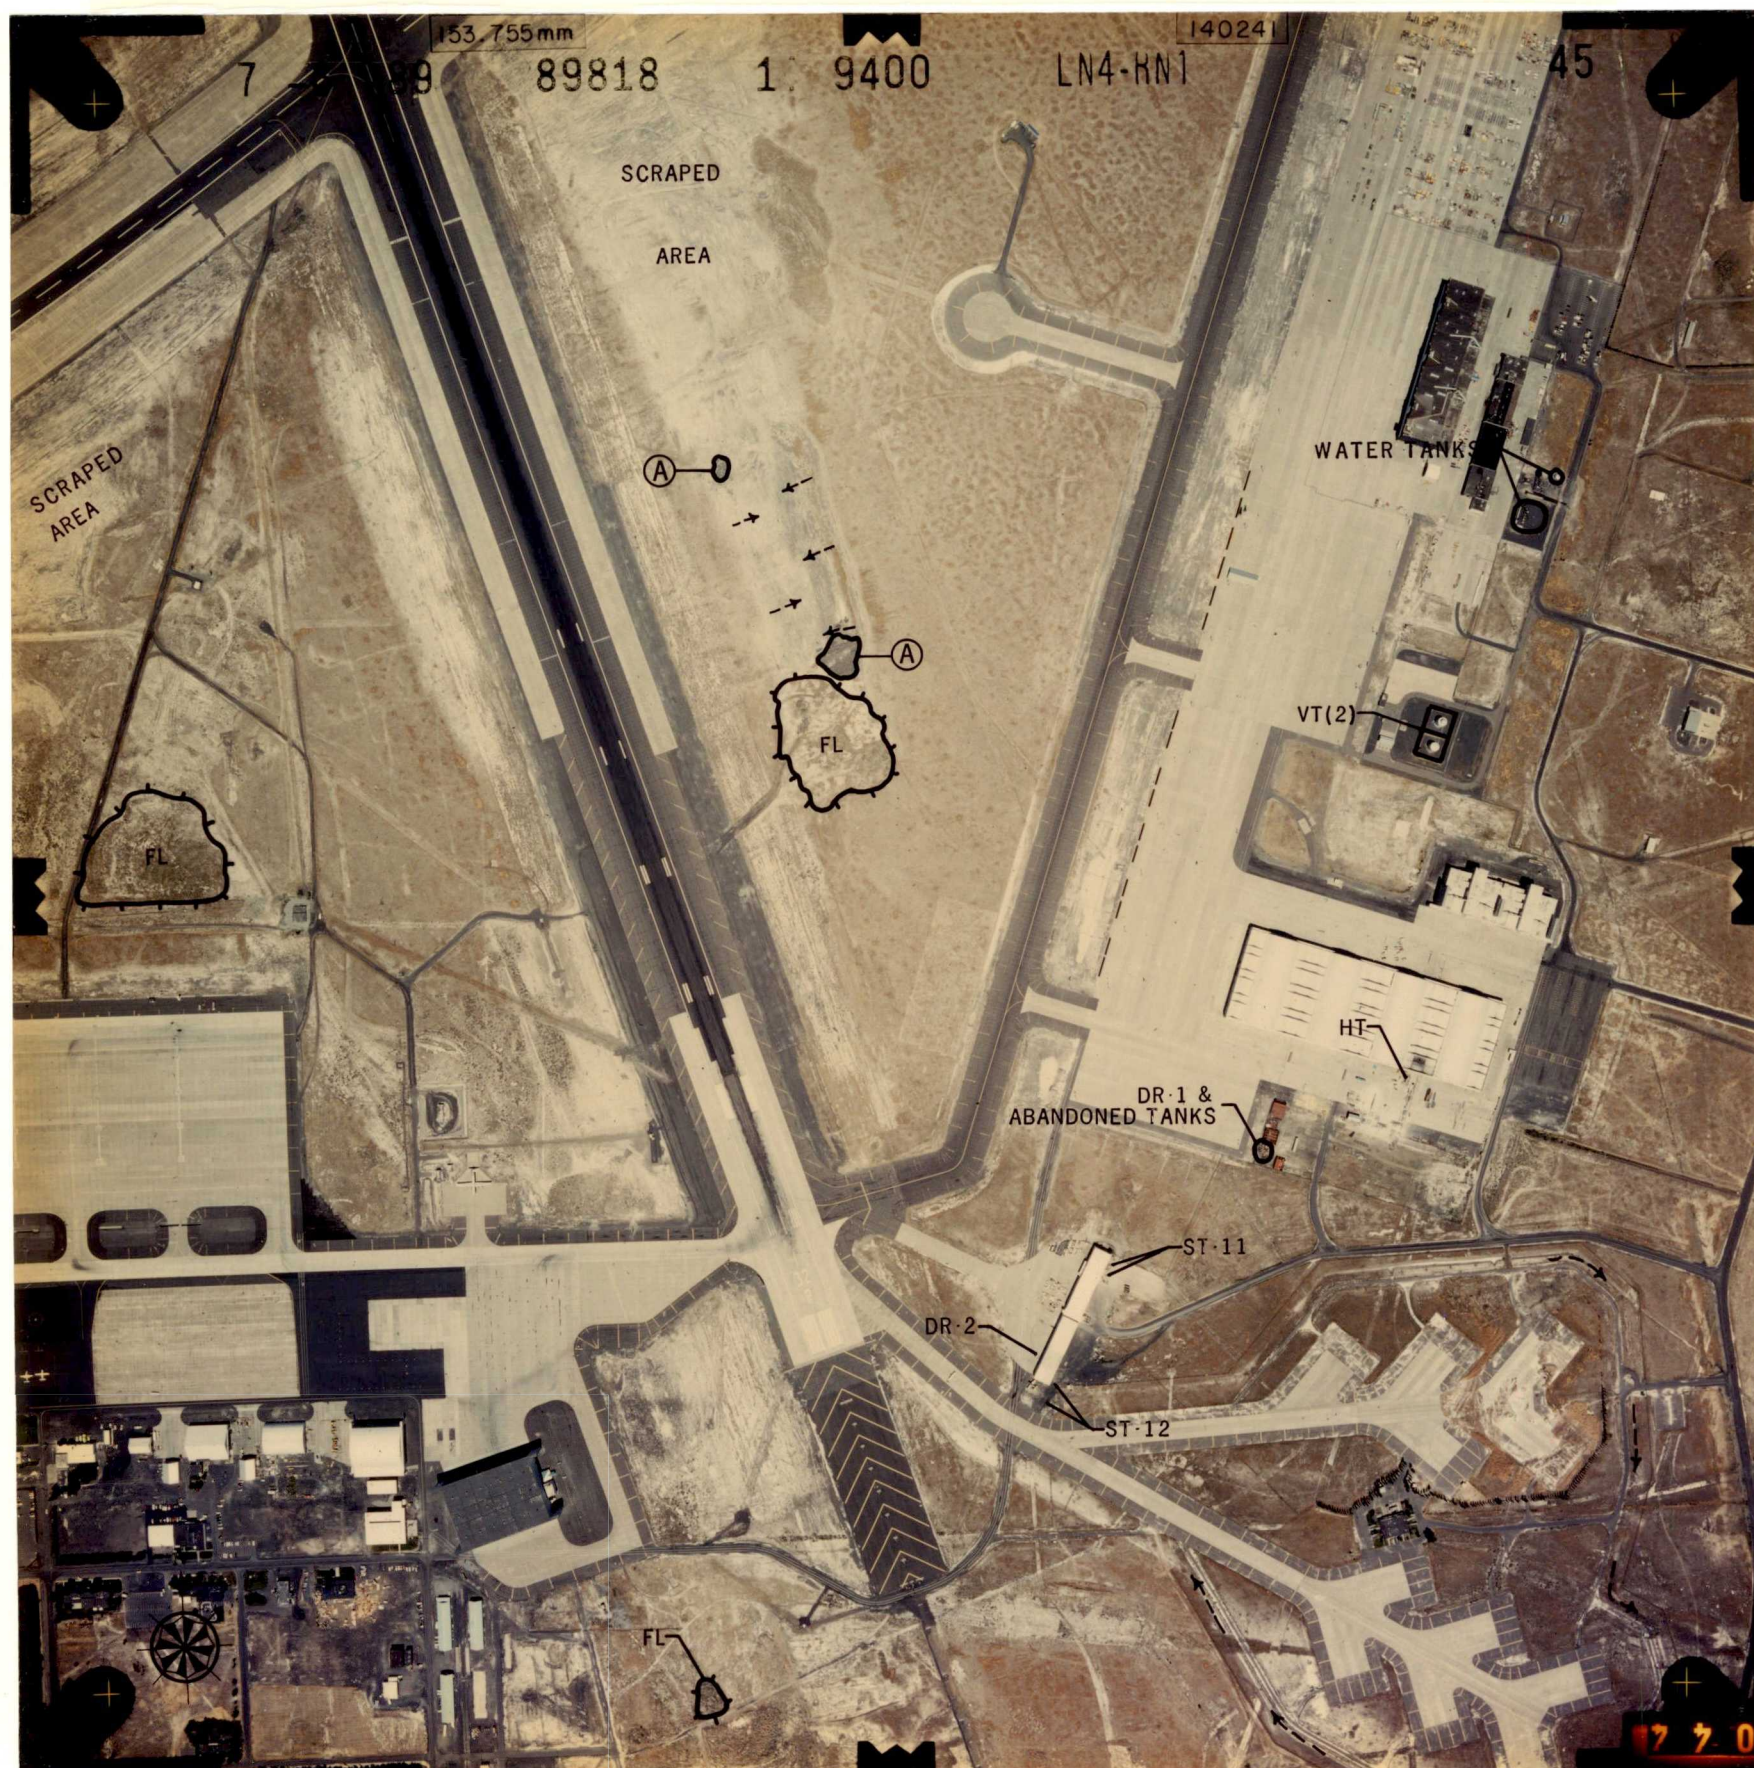
JULY 6, 1989 (13 of 20)

In this part of the study area, several new features are present. Potential environmental hazards are:

Tanks: A total of 46 blue and yellow drums and 4 black abandoned storage tanks are located at this point. Some discoloration of the soil is noted in this area suggesting that some leakage has occurred.

DR-2: Eight drums are being stored at this point. No leakage is visible.

ST-11: A number of minor oil spill stains are noted immediately outside a maintenance building. They are probably associated with aircraft repair operations.

ST-12: Two oil and fuel stains can be seen here. One is located below a parked airplane, while the other is in a nearby roadway. The source can not be determined.

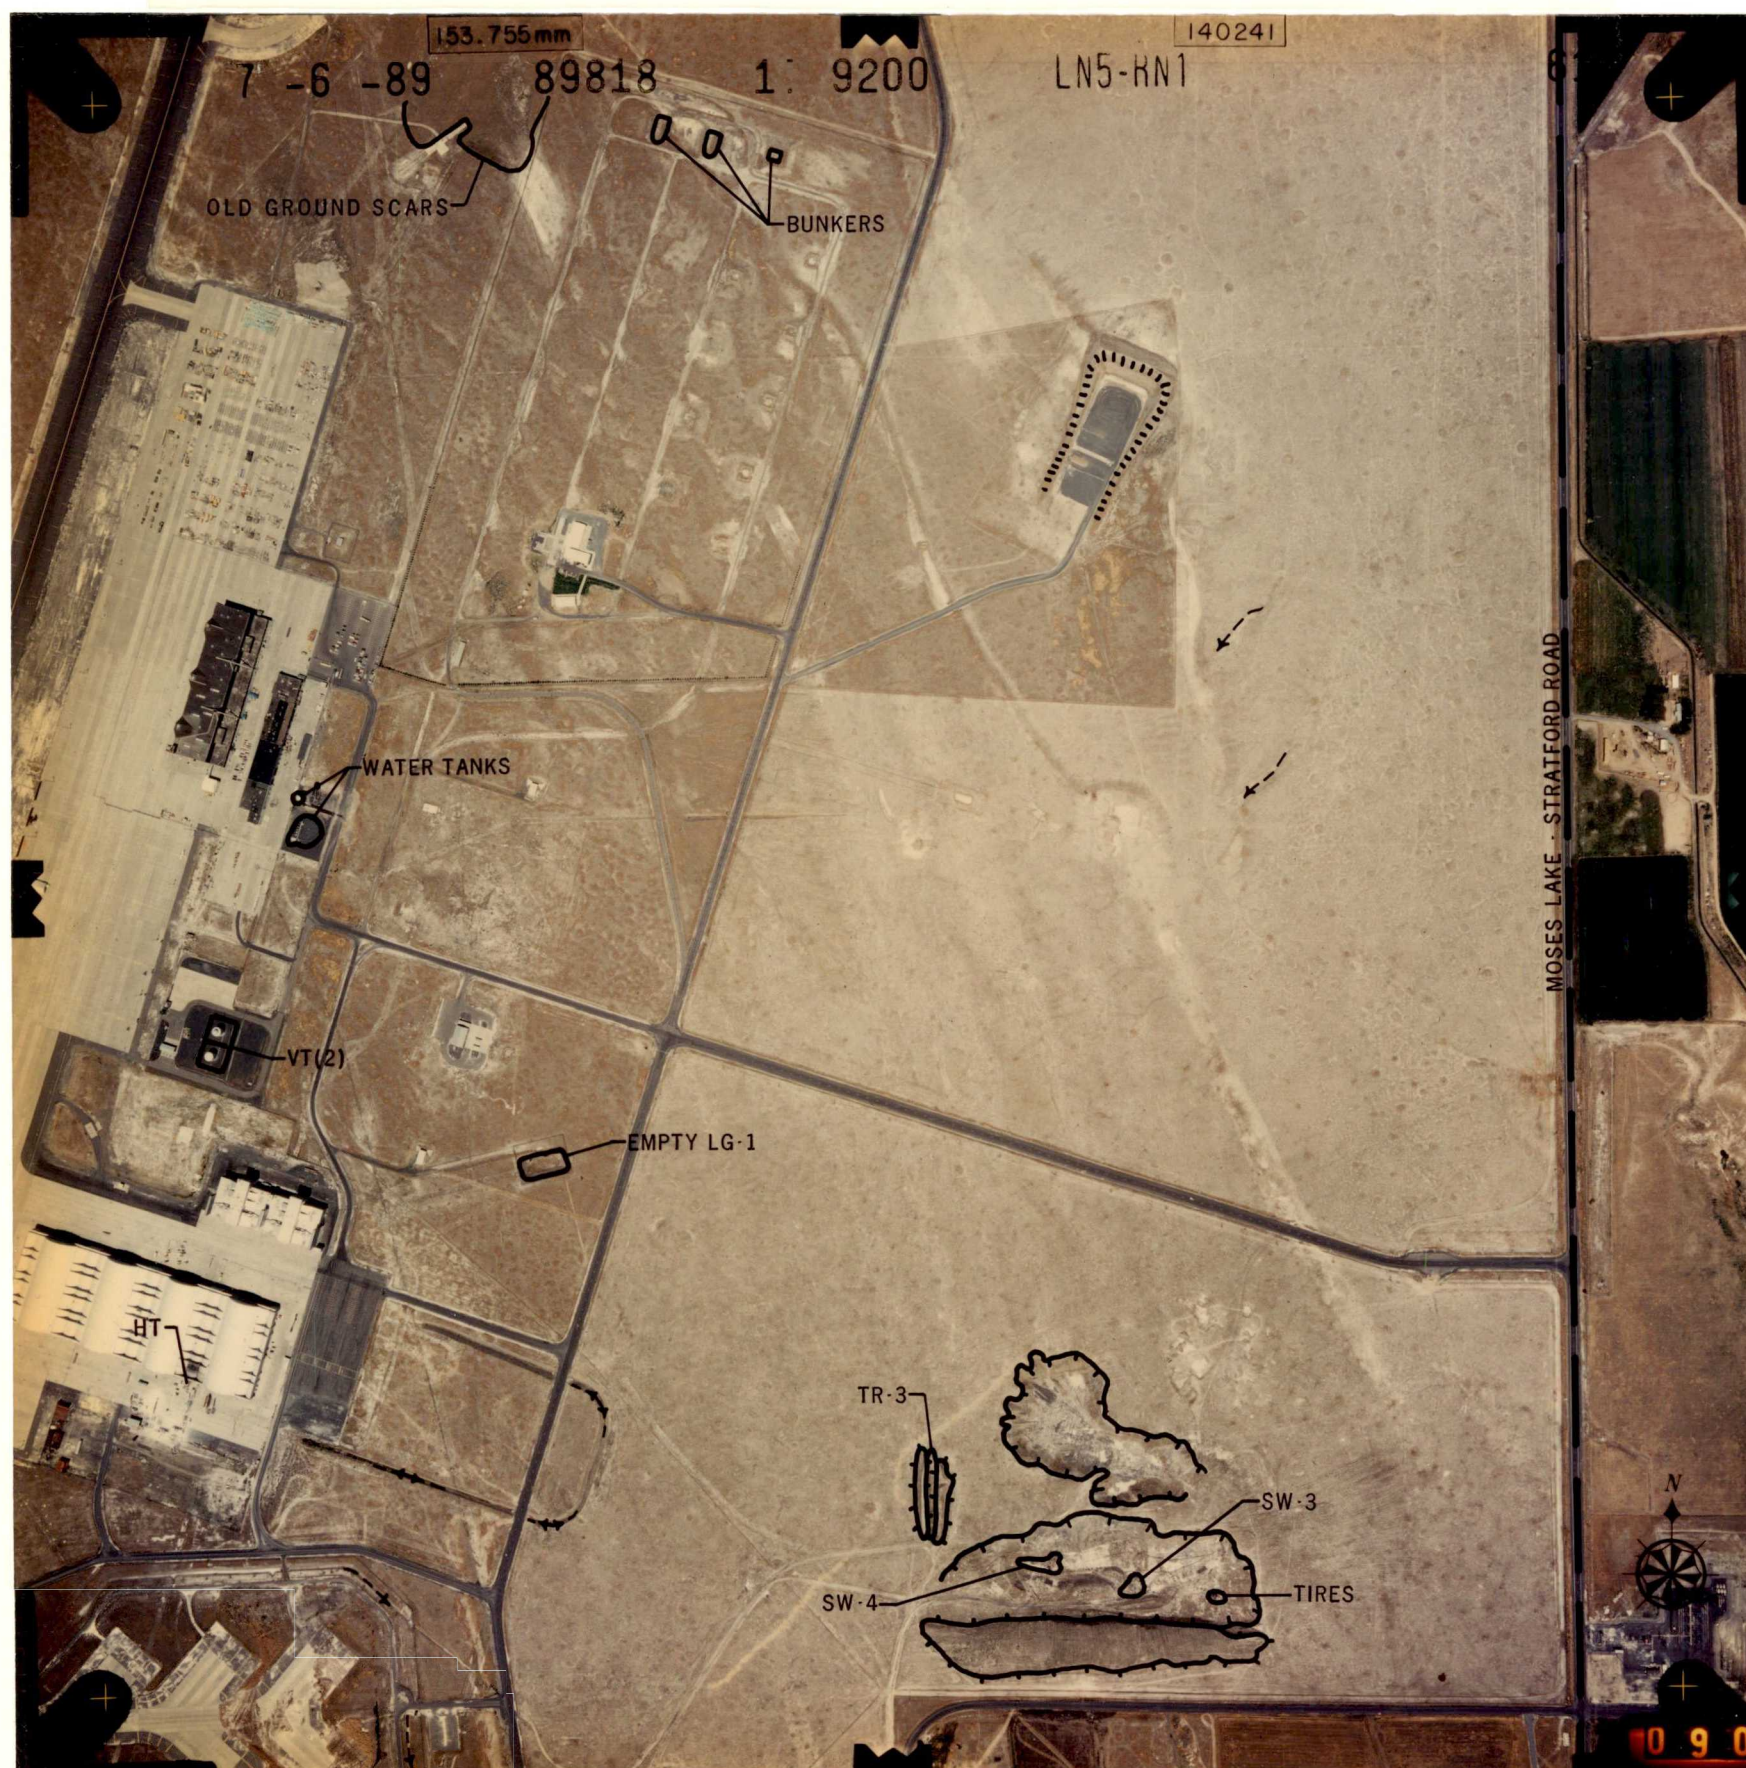
Figure 28 provides coverage of a waste disposal pit in the southern part of the frame. Potential environmental hazards area:

Empty LG-1: No change is noted.

TR-3: No change is noted.

SW-4: This solid waste contains essentially the same type of materials as SW-3.

A pile of old tires is also visible in this pit.

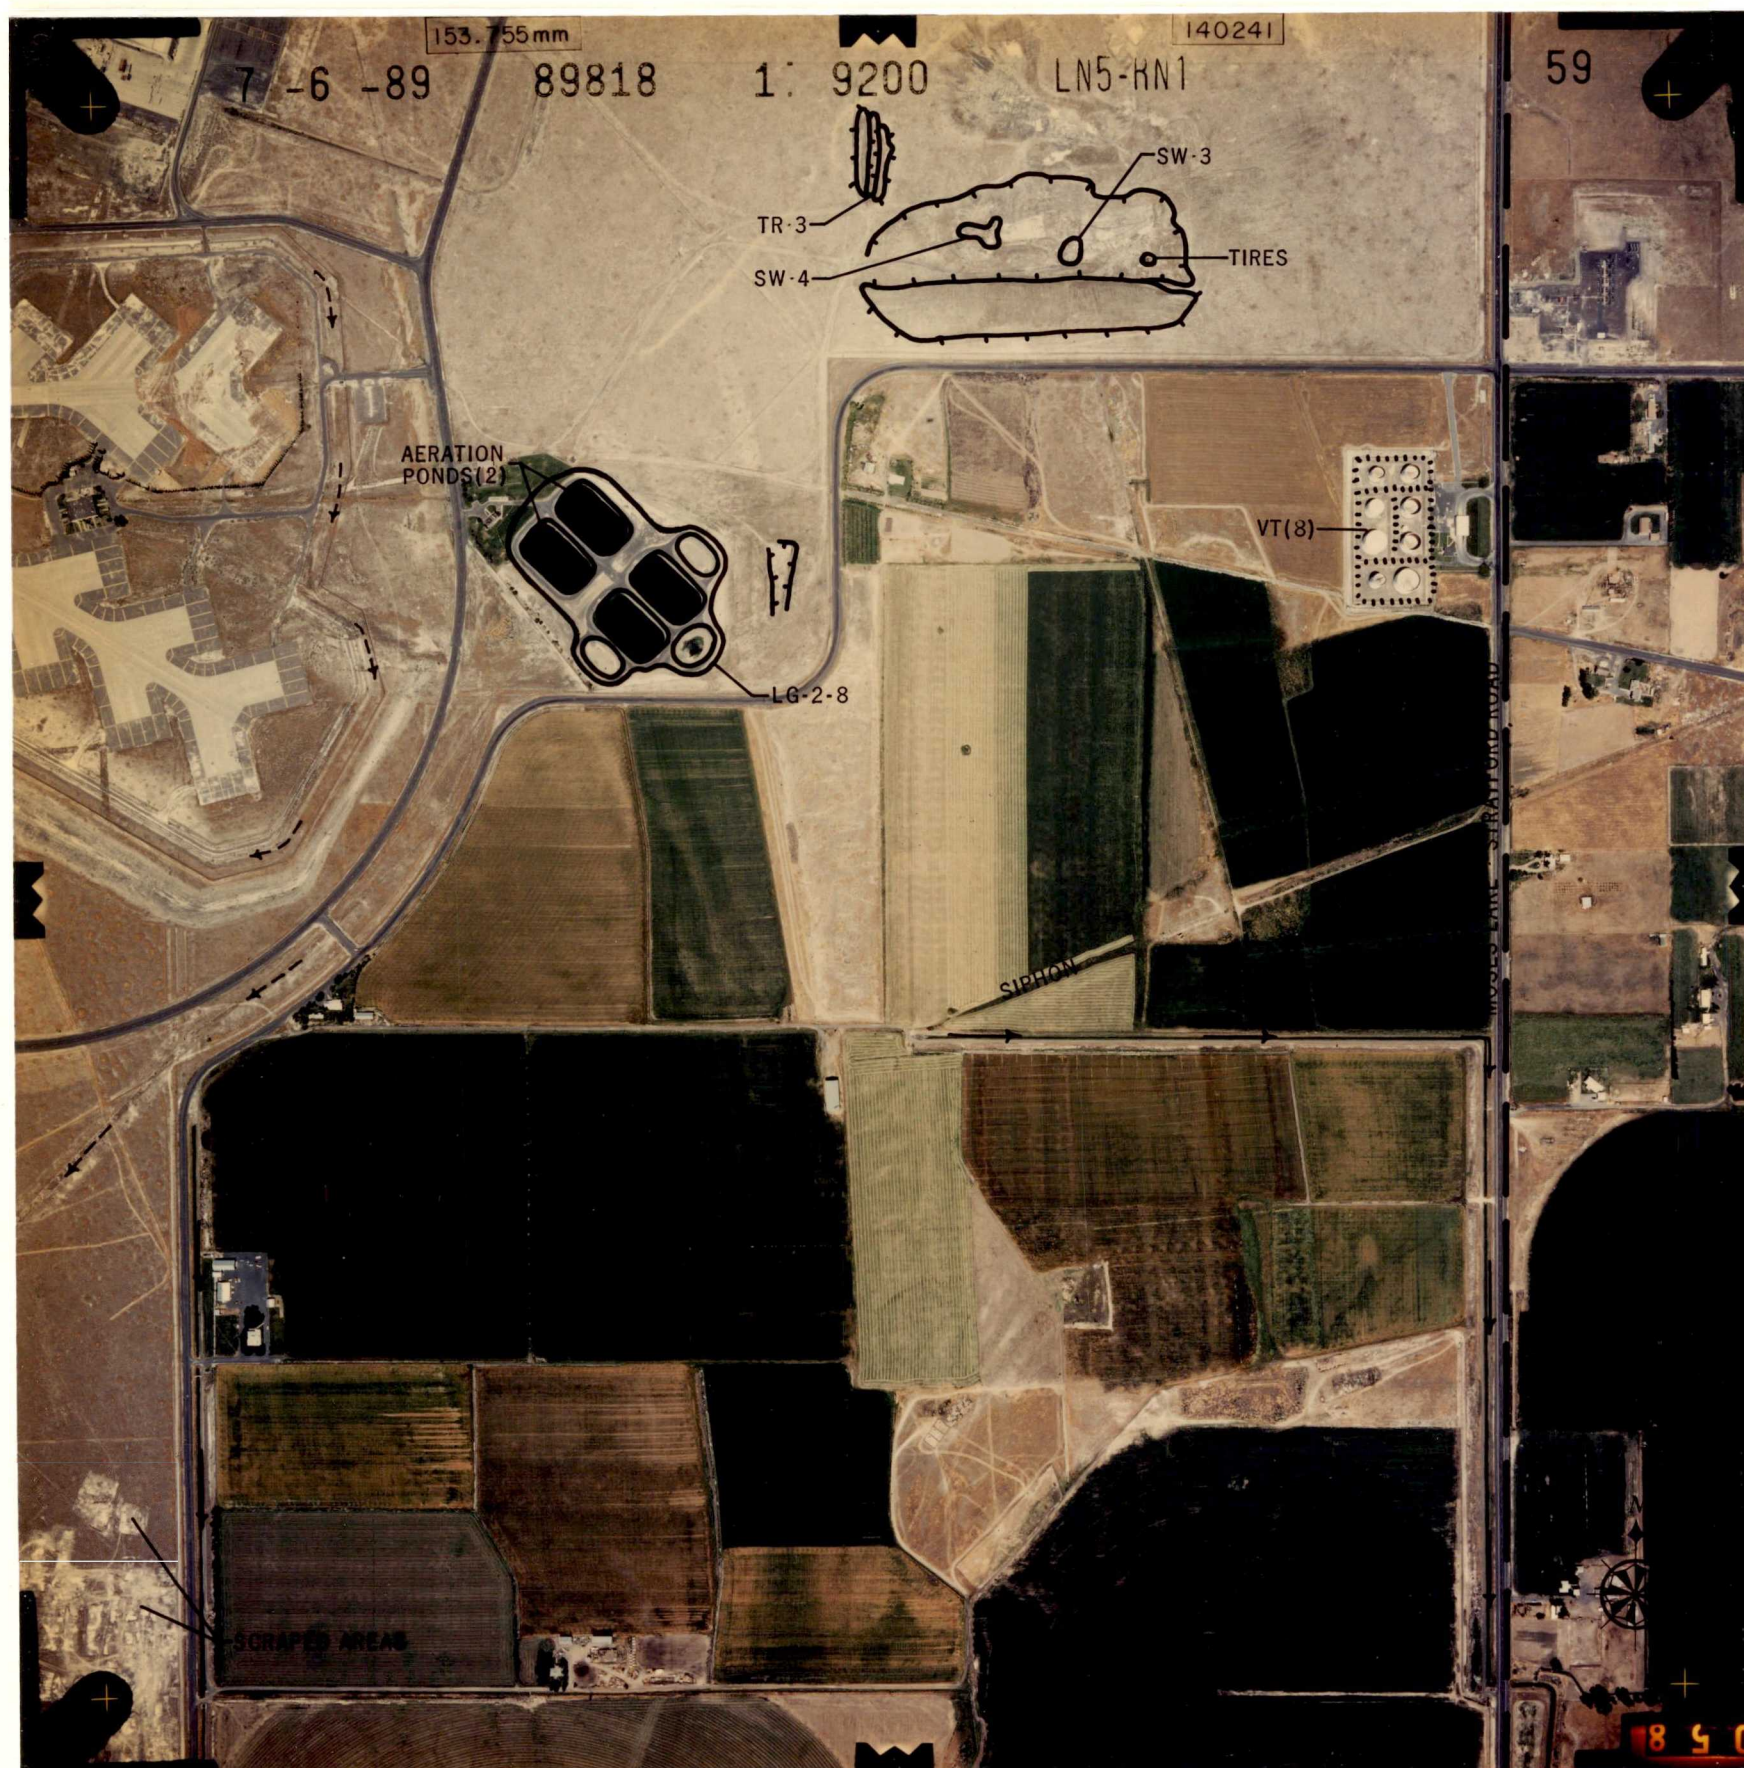
Figure 29 shows the completion of the waste water treatment plant. Dumping of liquid waste in the adjacent basin is no longer going on. Potential environmental hazards are:

LG-2-8: These lagoons are associated with the treatment plant and are now active. Two of the lagoons are aeration ponds which are operating at the time of the photography. Three of the remaining lagoons are empty at this time.
